Taylor Preston Limited

2018 Biofilter and Odour Extraction System Assessment

IZ082500| Final

March 2018

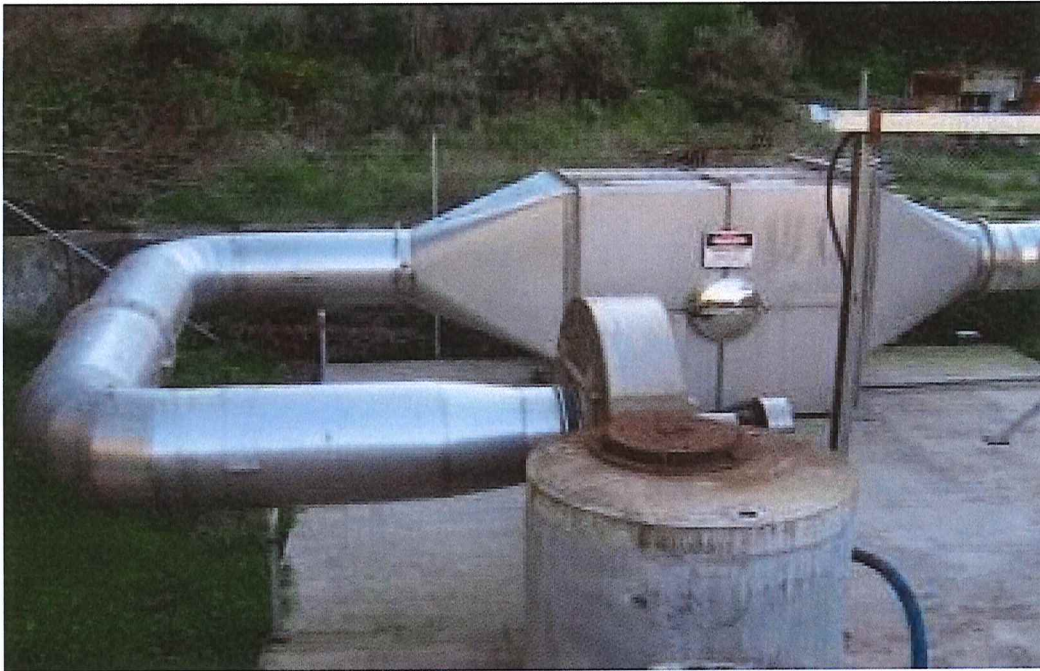
Photograph 1 Humidification Chamber

The humidification unit is depicted in Photograph 1 and Figure 1 below. The biofilter is depicted in Photograph 2 and Figure 2.

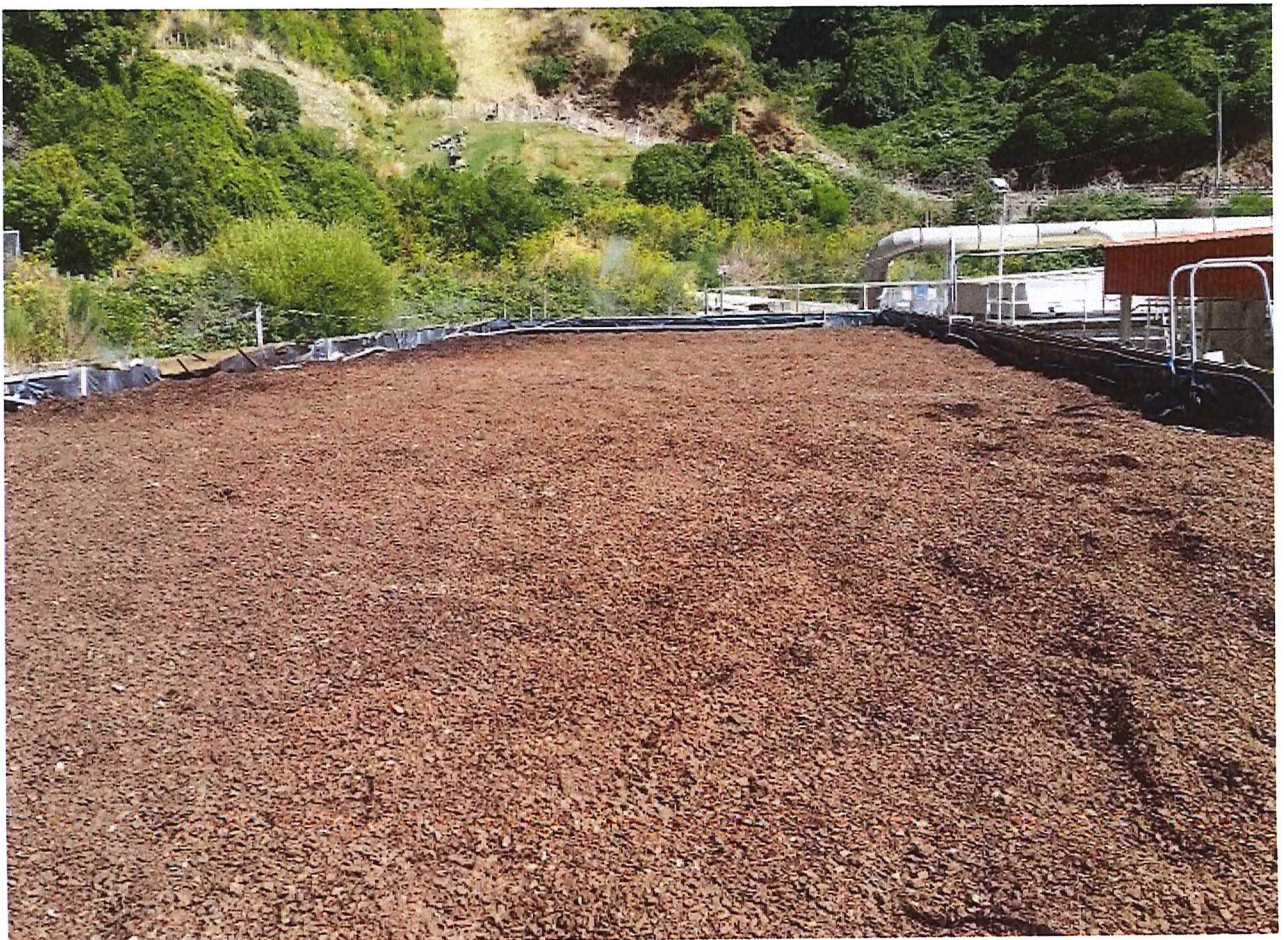
Photograph 2 Biofilter Surface as at 8th February 2018

Air flow was also observed from the biofilter bed surface, and no significant rendering odour was detected from the biofilter surface. The flow into the biofilter was measured at 23,800 m³/hr and the gas temperature was measured at 31°C. The bed of the biofilter was without weeds and appeared to provide even airflow across the surface.
